COLD SPRING DAM (UPPER)

PUTNAM COUNTY, NEW YORK INVENTORY NO. N.Y. 106

PHASE I INSPECTION REPORT NATIONAL DAM SAFETY PROGRAM.

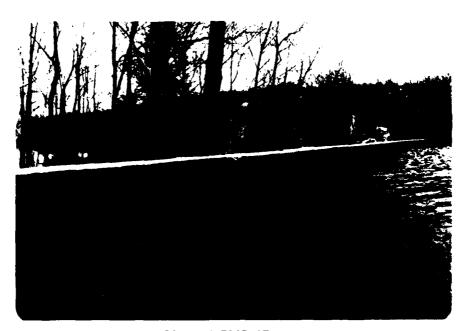
This dam is composed of laid up stone with concrete covering the crest and upstream face. While the concrete was generally in satisfactory condition, there were several areas where some deterioration was noted. The worst of these areas was a 25 foot long segment of the upstream wall at the left end of the dam. There was extensive spalling on the downstream face of this wall and water was seeping through the base, onto the crest apron (see photographs). There was also some deteriorated and cracked concrete noted in the vicinity of joints on the upstream face at the left end of the dam. Several other cracks were noted which extended through the wall. Many of the joints and cracks had been patched to reduce further deterioration.

UPSTREAM FACE OF DAM NOTE MINOR DETERIORATION AT JOINTS
